# Traditional wooden buildings and their damages during earthquakes in Turkey

## Abstract

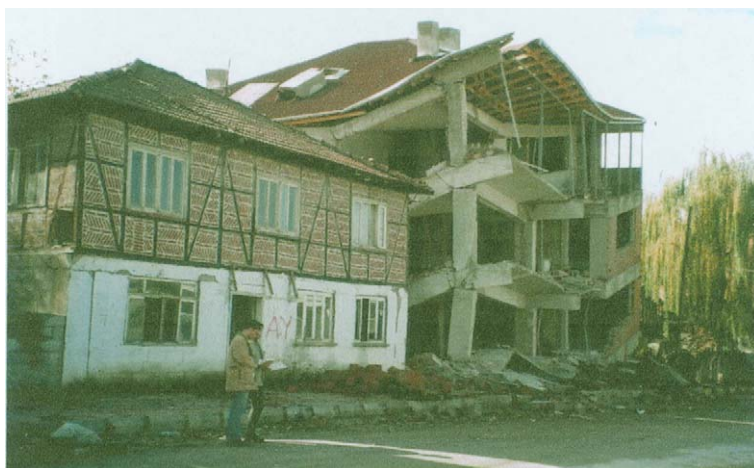
Fig. 1. View of traditional and reinforced concrete buildings after the 1999 Duzce earthquake.

Some traditional buildings were damaged due to collapse of neighbor modern reinforced concrete buildings (see Fig. 1). In at least three cases reinforced concrete structures hit or pounded against the timber frame buildings collapsing them during the 1999 Kocaeli earthquake.

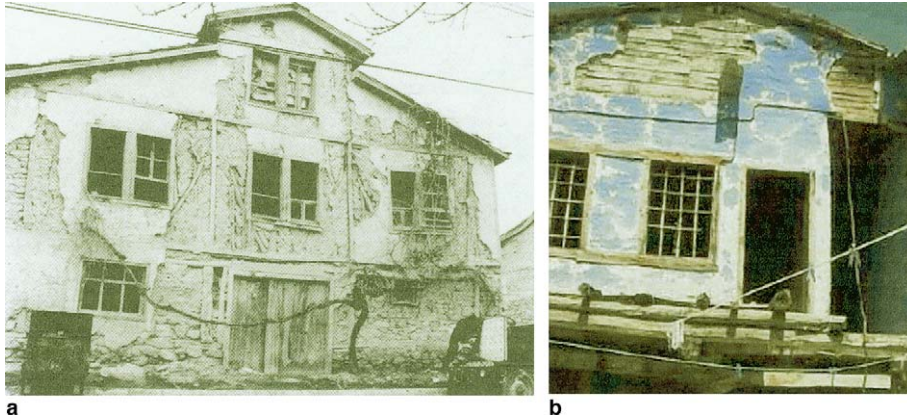
Its survival in the much larger and longer earthquake illustrates that the timber framed buildings is capable of maintaining stability over many cycles. To do this, however, the deflection of the structure and friction in the infill must begin at the onset of shaking. Thus, different from reinforced and masonry buildings, for timber framed buildings the shedding of the plaster and stucco in both the large and small earthquakes was similar. In other words the working of bracing elements in the earthquake dislodged the plaster as the oscillated building. The closely spaced studs reduced the likelihood of the propagation of cracks within masonry infill. The only visible manifestation of earthquake excitation was the presence of cracks in the interior plaster along the walls and at the corners of the rooms, revealing the pattern of the timbers imbedded in the masonry underneath. This level of damage was evident in every traditional timber framed buildings after a moderate or larger earthquake (Fig. 10). On the exterior, unless the masonry was covered with

Fig. 10. Views of cracked and fallen plasters during earthquake excitations. (a) A view of himiş construction after the 2002 Sultandağı earthquake [29]. (b) A view of bağdadi construction after the 2003 Buldan earthquake [15].

stucco, it is difficult to see damage with the naked eye. It should be noted that many walls were missing some of their infill, but evidence of 'X' cracks, so common in the infill in the modern reinforced concrete buildings [28], was non-existent in the traditional timber framed buildings.

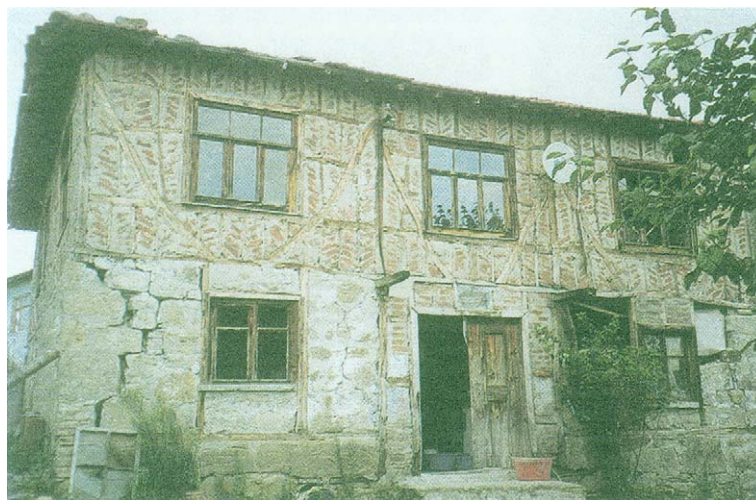
An important factor in the performance of the walls was the use of weak, rather than strong mortar. Fig. 11 shows failure of mortar in stone masonry infill during the 1999 Düzce earthquake. As a result of the different types of people constructing houses, it is not surprising to see that construction quality is variable. It is poor when; field rubble is used and bonded with mud mortar, without quoins and with no through stones etc. Especially during the moderate earthquakes (Doğubeyazıt, Erzurum, Pülümür and Çankırı Earthquakes), as given in Table 1, since the energy release was relatively small, none of or only

Fig. 11. View of failure of lime mortar during 1999 Düzce earthquake [30].

a few of reinforced concrete structures, slightly were damaged during these earthquakes. However, mud-stone masonry and Hatıl constructions destroyed due to poor mud mortar and weak anchorage between mud and stone. The mud or weak lime mortar encouraged sliding along the bed joints instead of cracking through the masonry units when the masonry panels deformed. This served to dissipate energy and reduced the incompatibility between rigid masonry panels and the flexible timber frame.

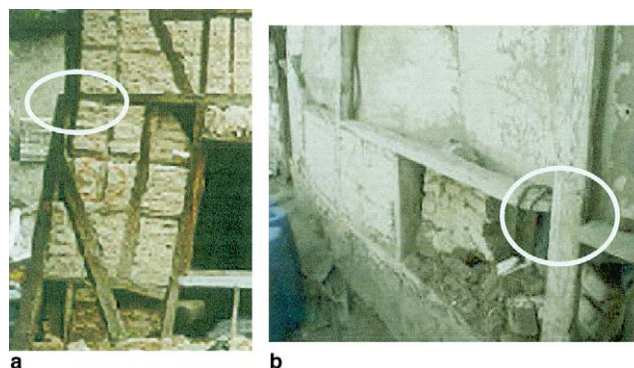
The connections of roof, floors, vertical framing elements and bracing elements make the building a single solid structure unit and are important features for holding a building together during earthquakes. Thus, the connections between the members must be strong enough to hold together without loosening or worse yet completely failing. It is extremely unlikely that a traditional timber framed building have not bracing element, could ever effectively resist lateral movements. As lateral earthquake effects are resisted by stiffness of connections, it would simply deform and collapse. Fig. 12 shows two connection failures during the 1999 Kocaeli earthquake and 2003 Buldan earthquake.

Fig. 12. Failure of connections in traditional timber buildings during earthquakes (a) Failure of connections during the 1999 Kocaeli earthquake [20]. (b) Failure of connections during the 2002 Buldan earthquake [15].

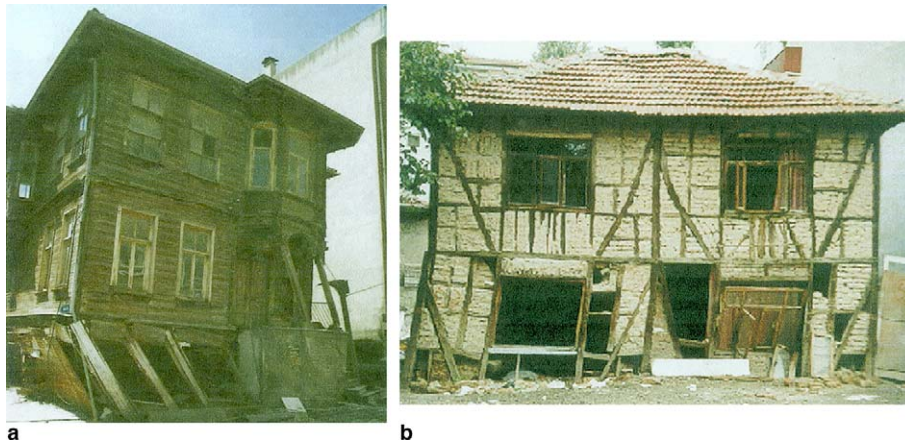
A large number of residential and commercial buildings built in Turkey had soft stories at the first-floor level on the two sides of main streets, because the first stories have been often used as stores and commercial areas [31]. These areas are generally enclosed with glass windows instead of brick infill walls so as to be used as showrooms. If first story of traditional timber building had more voids and fewer walls, it may behave as a soft story during an earthquake. The ground story of the buildings shown in Fig. 13 was heavily damaged,

Fig. 13. Heavily damaged traditional wooden buildings due to soft story. (a) Large laterally displaced traditional building [26]. (b) Laterally displaced traditional building [20].

but damage on the upper stories was limited and even the glass windows were unbroken. As seen from Fig. 13(b) a traditional building displaced laterally due to soft story although it has bracing element. As its bracing elements were not satisfied to resist lateral loads, still they prevented totally collapse.

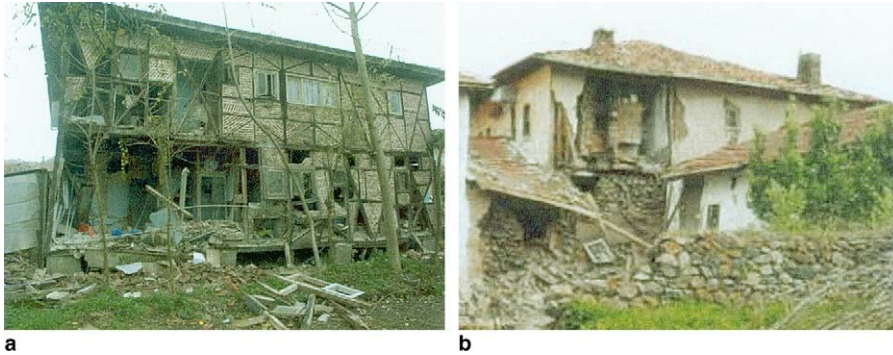
In many ways, the masonry infill dominated the performance of the frame, stiffening and strengthening it. It was evident that the infill masonry walls responded to the stress of the earthquake by “working” along the joints between the infilling and the timber frame; that is, the straining and sliding of the masonry and timbers dissipated a significant amount of the energy of the earthquake. In addition, by dissipating energy, the “working” also affects the natural vibration frequency of the structure.

Fig. 14. Masonry falling out of the frames for traditional himiş constructions. (a) Damaged during 1999 Kocaeli earthquake [7]. (b) Damaged during 2000 Çankırı earthquake [19].

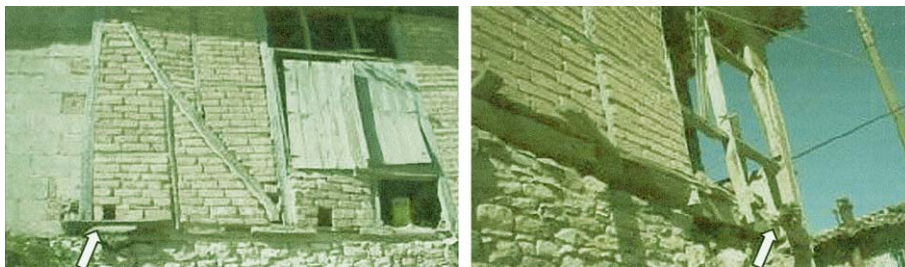
that these buildings may slide off their foundation during earthquakes. Fig. 15 shows two himiş constructions whose vertical framing elements were slide off their foundation during the 2003 Buldan earthquake. If reinforced concrete foundation and anchor bold are used, it is prevented structures from moving off its foundation.

Fig. 15. Slide off frame elements from supporting systems during the 2003 Buldan earthquake [15].

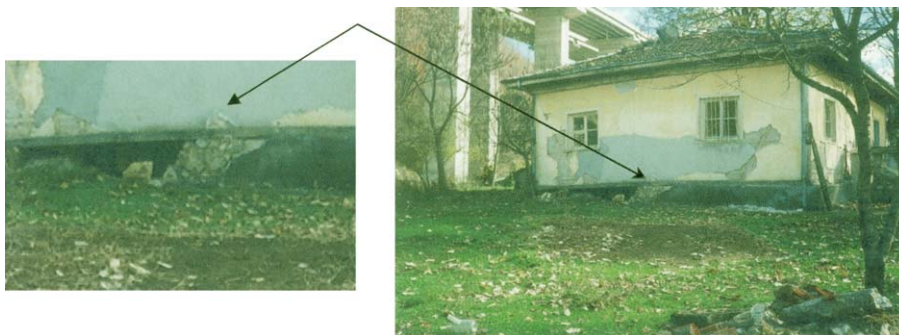
Fig. 16 shows failure of stone masonry foundation wall during the 1999 Düzce earthquake. But it should not be accused too much since fault rupture crossed just under the building as shown in the figure. Yet, it succeeded to survive during the earthquake with only repairable foundation failure.

Fig. 16. Failure of masonry foundation of a himiş construction just over the fault rupture during the 1999 Kocaeli earthquake.

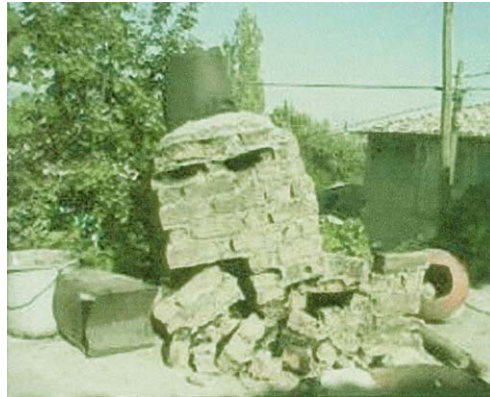
Fig. 17. A collapsed chimney of traditional building during the 2003 Buldan earthquake [15].

Failure of the chimneys can generally cause damage to the roof and walls of the building below. But especially in some kinds of Turkish traditional buildings the failure of chimney may cause fire. Fig. 17 shows failure of a chimney during the 2003 Buldan earthquake. Unreinforced masonry chimneys are particularly susceptible to earthquake damage. Also damaged chimneys may be dangerous in aftershocks following the initial earthquake. Bracing chimneys or using chimneys from lighter materials can help prevent damage [32].
