# Traditional wooden buildings and their damages during earthquakes in Turkey

## Abstract

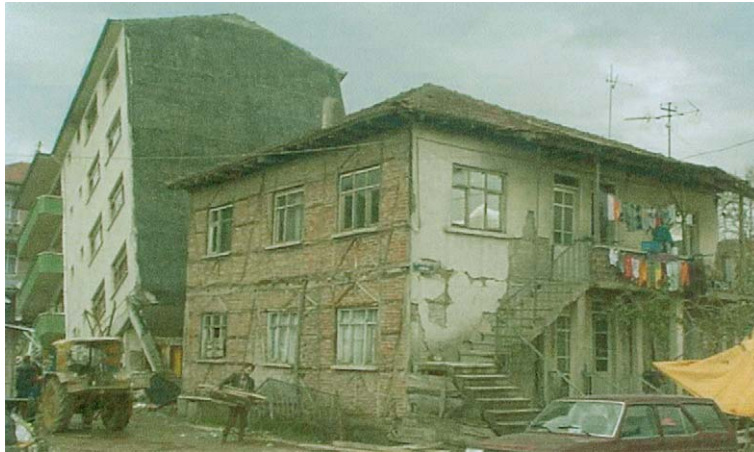
Fig. 2. A view for neighbor traditional and reinforced concrete buildings after the 1999 Duzce earthquake [7].

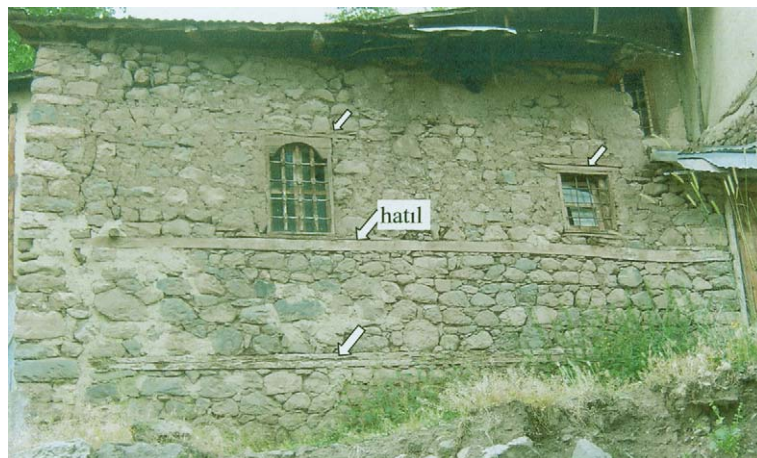
Fig. 4. Traditional hatıl construction in Turkey.

modifying the earthquake damage, was not easy to appreciate, but thought to be moderately significant. As previously noted, many of the affected structures were highly decayed; therefore, wall top/roof collapse and granular disintegration occurred. The Hatils systems as seen could not aid in resisting this sort of failure. It was clear that the hatils when tied around the facade-side wall junctions did aid in reducing the significance of corner wedge failures. It would appear that long doorway and window lintels aided in redirecting crack propagation [9].

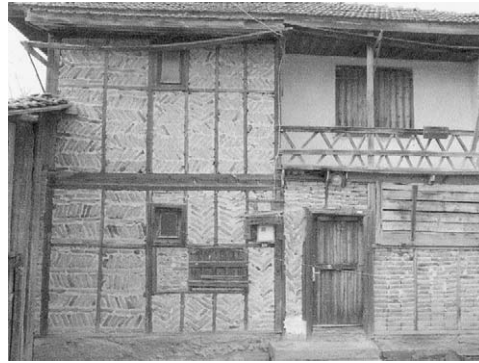
It is possible to classify traditional hıms construction depending on the structural systems and masonry infill. Here, it is divided into two categories for structural system such as; system contained bracing elements and no bracing elements (Fig. 6). In this system studs are themselves tied by only other horizontal timbers. In this buildings, vertical timber elements do not subjected to tension direction to grain whereas timber have high specific strength for this grain direction. Structural timber, with all of its natural defects, shows an unquestionable brittle character under certain when subjected to shear or tension perpendicular to grain direction. Thus, it is not expected to resist lateral forces without damage during an earthquake due to low lateral stiffness of the frame system as shown in Fig. 6.

Fig. 6. Traditional building with brick infill and no bracing elements.
