Recent earthquakes and the need for a new philosophy for earthquake-resistant design

Jiro Takagi^{a,*}, Akira Wada^b

Sustainable development goals (SDGs)
Earthquake disasters
Seismic design philosophy
Damage control

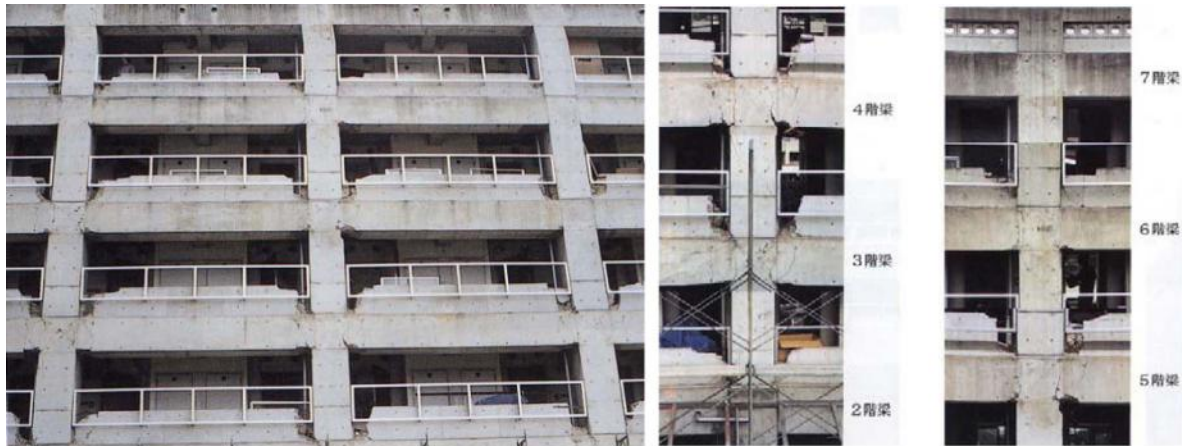
(a) Flexural cracks of beams

Fig. 2a shows a reinforced concrete residential building designed and constructed to comply with the 1981 revision. It was significantly damaged by the Great Hanshin earthquake in 1995. As shown in the figure, major flexural cracks were observed in many beams near the column connections. This damage had been expected in the design. As designed, the plastic deformation dissipated the earthquake energy and saved human lives. In this sense, the building was successfully designed;

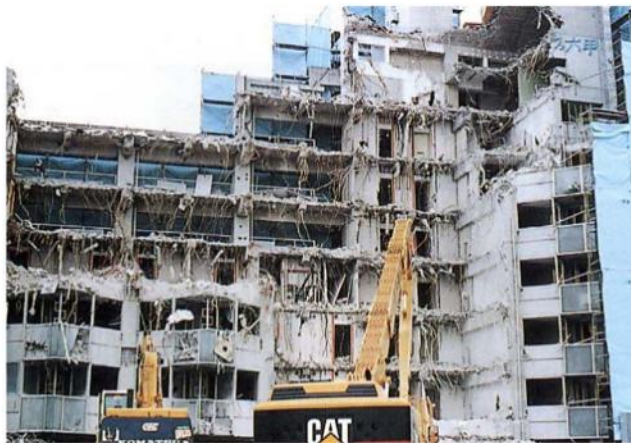
(b) Demolished building

however, the building was eventually demolished rather than being repaired (Fig. 2b).

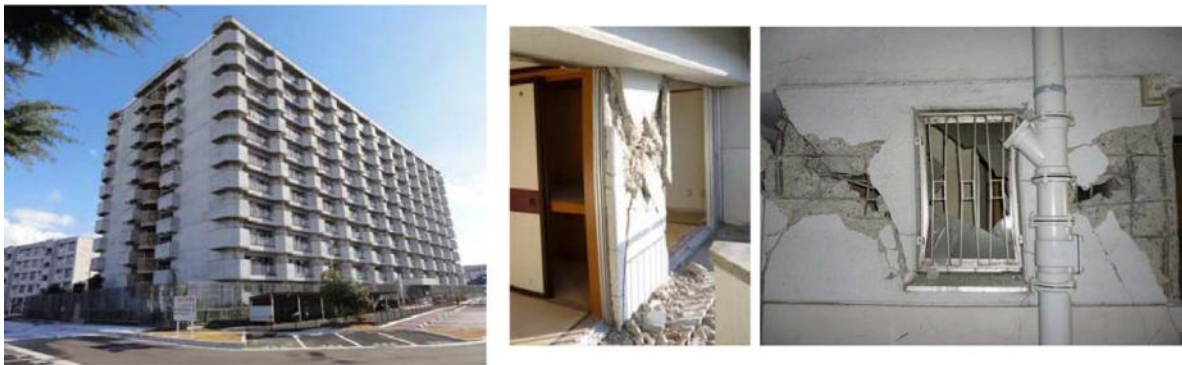
(a) Non-structural walls failed in shear

Fig. 3. Damaged and demolished residential building in the Great East Japan earthquake.

Fig. 3 shows a residential building damaged by the Great East Japan earthquake in 2011. The columns, beams and non-structural reinforced concrete walls were damaged. The damage in the non-structural walls was particularly severe and they failed in shear. This type of damage is not critical for building stability. In this sense, this damage had been expected and the structure behaved as predicted in the design. The damaged walls had absorbed the seismic energy; however, the walls were no longer functional as the building's exterior. While the structural designer or seismic engineering specialist may consider the design to have been successful, lay people, including the residents, may not have agreed. The building was red tagged in the emergency evaluation and the residents were prohibited from returning to their homes. The building was later demolished.

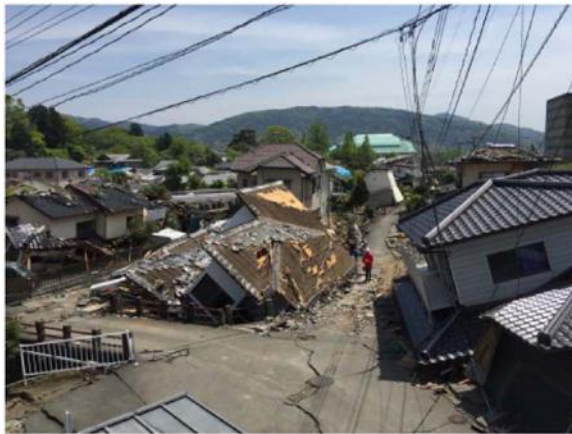
(a) Collapsed wooden houses

In the 2016 Kumamoto earthquake, the vulnerability of old wooden houses, which is well known in the engineering community, was again observed (Fig. 5a). In a reinforced concrete hospital building of conventional design, the equipment fell due to the large acceleration.

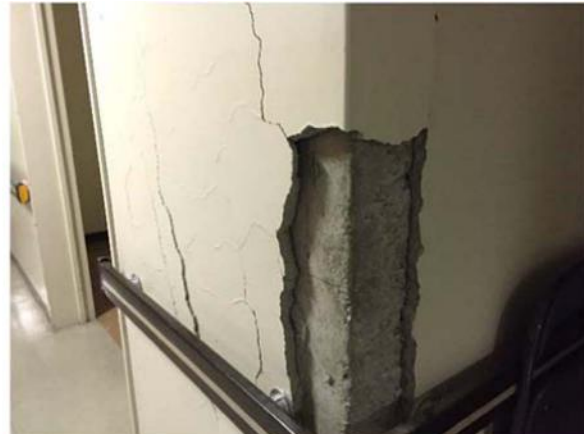
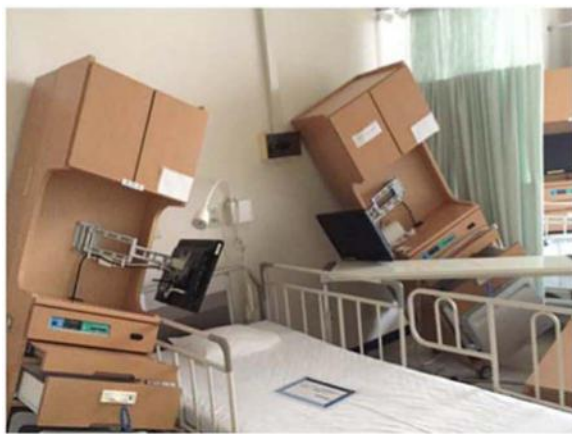
(b) Minor cracks on columns

(c) Fallen equipment

Minor cracks were observed in the columns and walls (Fig. 5b, c). Although these types of damage do not affect the seismic performance of the structure, people in the building, including 300 patients and doctors, had to be moved to other hospitals (Fig. 5d) and the hospital was not used for rescue activities.

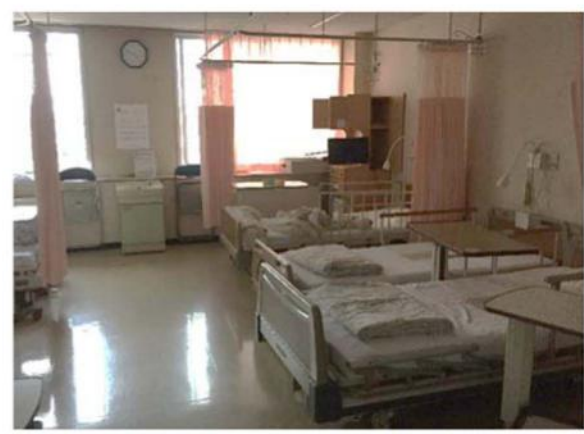
(d) Empty room with patients evacuated

Fig. 5. Damages by the 2016 Kumamoto earthquake.

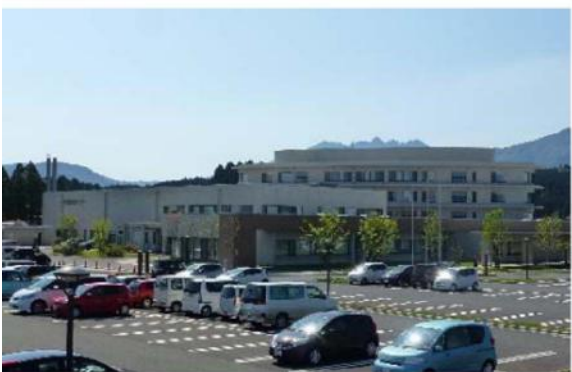
(e) Seismically isolated hospital building

Another seismically isolated hospital building (Fig. 5e) experienced large movement, with a maximum amplitude of 900 mm (i.e. a maximum displacement of 450 mm) (Fig. 5f). This is the largest displacement ever recorded in past earthquakes. Despite experiencing this large displacement, the superstructure was almost intact and the building was fully active after the earthquake and was able to accommodate the Disaster Medical Assistance Team (DMAT). Many structures designed by new technology have not fully experienced severe earthquakes nor proved their performance; however, there are certainly some structures like this hospital had experienced and no damage.

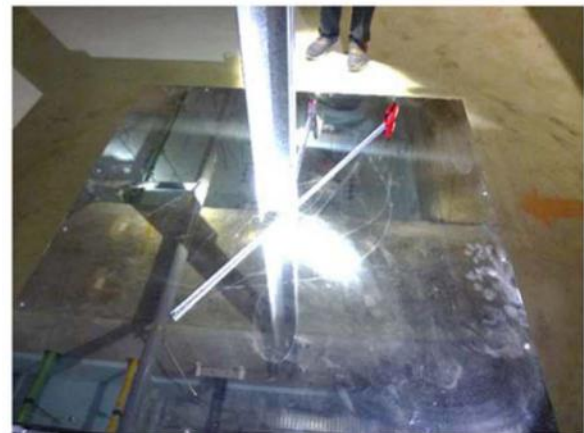
(f) Maximum displacement of 450 mm

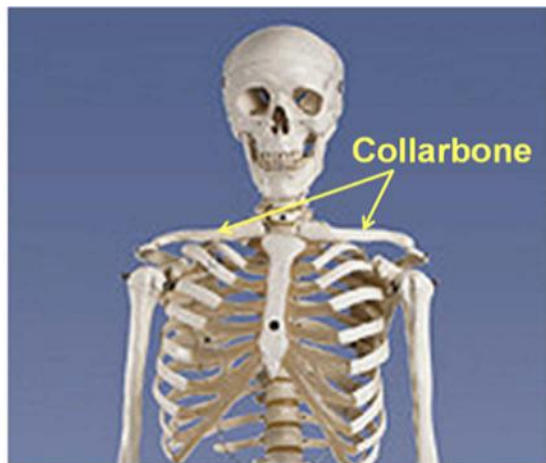
(a) Collarbone

In order to achieve the goals of the new seismic design approach shown in Table 1, an effective method of design would allow structural components play separate roles. The primary structure supports the gravity load and the seismic members mainly resist earthquake loads. Therefore, the seismic members protect the primary members against large earthquakes. Similar systems to protect the main body are often found in nature and industrial products. Collarbones are broken to ease forces on the human body (Fig. 6a). Bumpers in cars are obviously components to protect the main body (Fig. 6b). Fuses in computers are buffers to protect the main system against excessive electric currents (Fig. 6c).

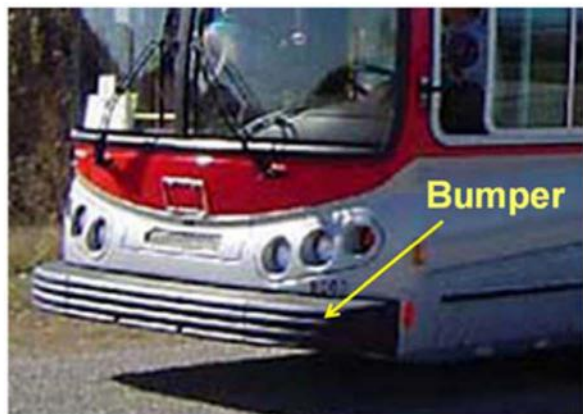
(b) Bumper

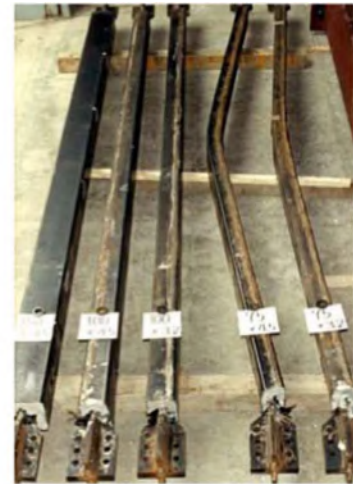
(b) Experiments of BRBs

Fig. 7a illustrates the concept of a structural system with seismic members and a primary structure. Buckling Restrained Braces (BRBs) represent the seismic members, which are separated from the primary structure. The ductile BRBs will yield and absorb the earthquake energy to the buildings (Fig. 7b, c). They protect the primary structure, which remains elastic, and the goals of H, B and C for the new seismic design approach in Table 1 can be satisfied.

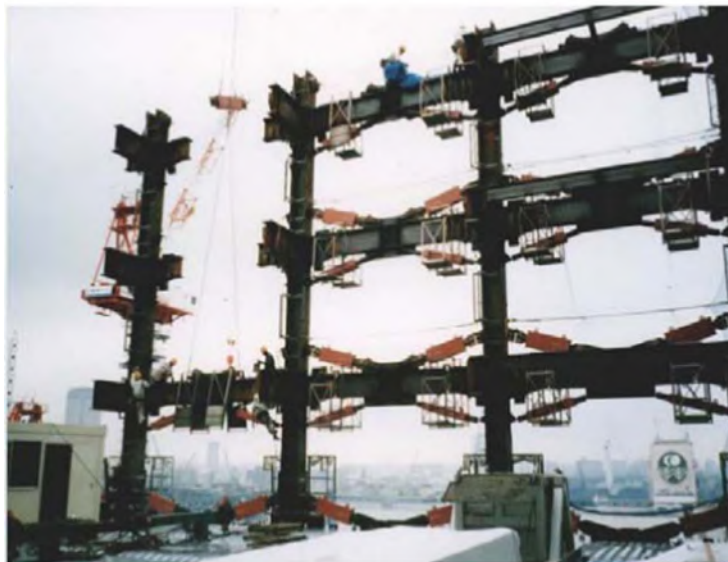
(c) Application of BRBs

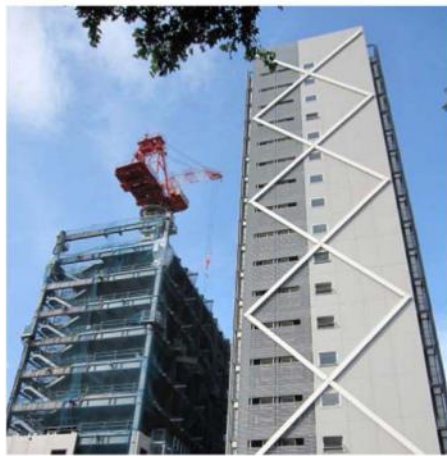
(a) Exterior frame

Fig. 9 shows seismically isolated buildings at the Tokyo Institute of Technology (TITech) designed under the new seismic design approach

shown in Table 1. The structure has 20 stories and is 91.35 m in height. Columns of the superstructure consist of concrete-filled square tube (CFT) columns, and all beams are made of steel wide flange sections. The seismic lateral forces are significantly reduced by the effect of seismic isolation and the number of the CFT columns is 16, which is fewer than that in ordinary structural systems. The seismic isolation

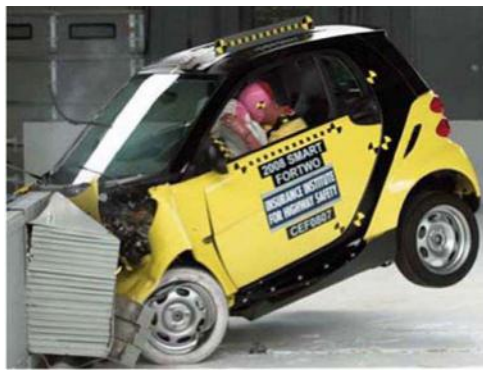
(a) Damage of a single vehicle [7]

Fig. 11. Safety design of vehicles and buildings.

Fig. 11 illustrates the difference in safety design between vehicles and buildings. The design philosophy of protecting the lives of drivers and passengers by sacrificing the engine or main body of the vehicle is desired for major traffic accidents (Fig. 11a) [7]. These traffic accidents are generally local events and do not happen simultaneously in multiple

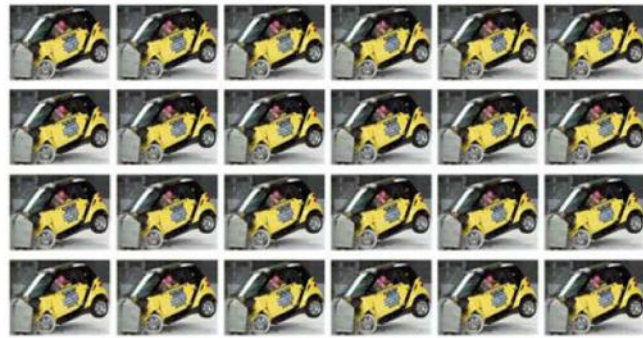
(b) Simultaneous damage not happening in vehicles but happening in buildings under large earthquakes
